## TEST DIRECTOR'S REPORT FOR

## HEMP SIMULATION TEST,

**TEST DIRECTOR'S REPORT FOR**  
**[REDACTED]**  
**HEMP SIMULATION TEST**

This report documents the on-site test activities for the Advanced Fixed-Ground Based Electromagnetic Pulse (EMP) Testing program (AFEMPT) High-Altitude EMP (HEMP) simulation test.

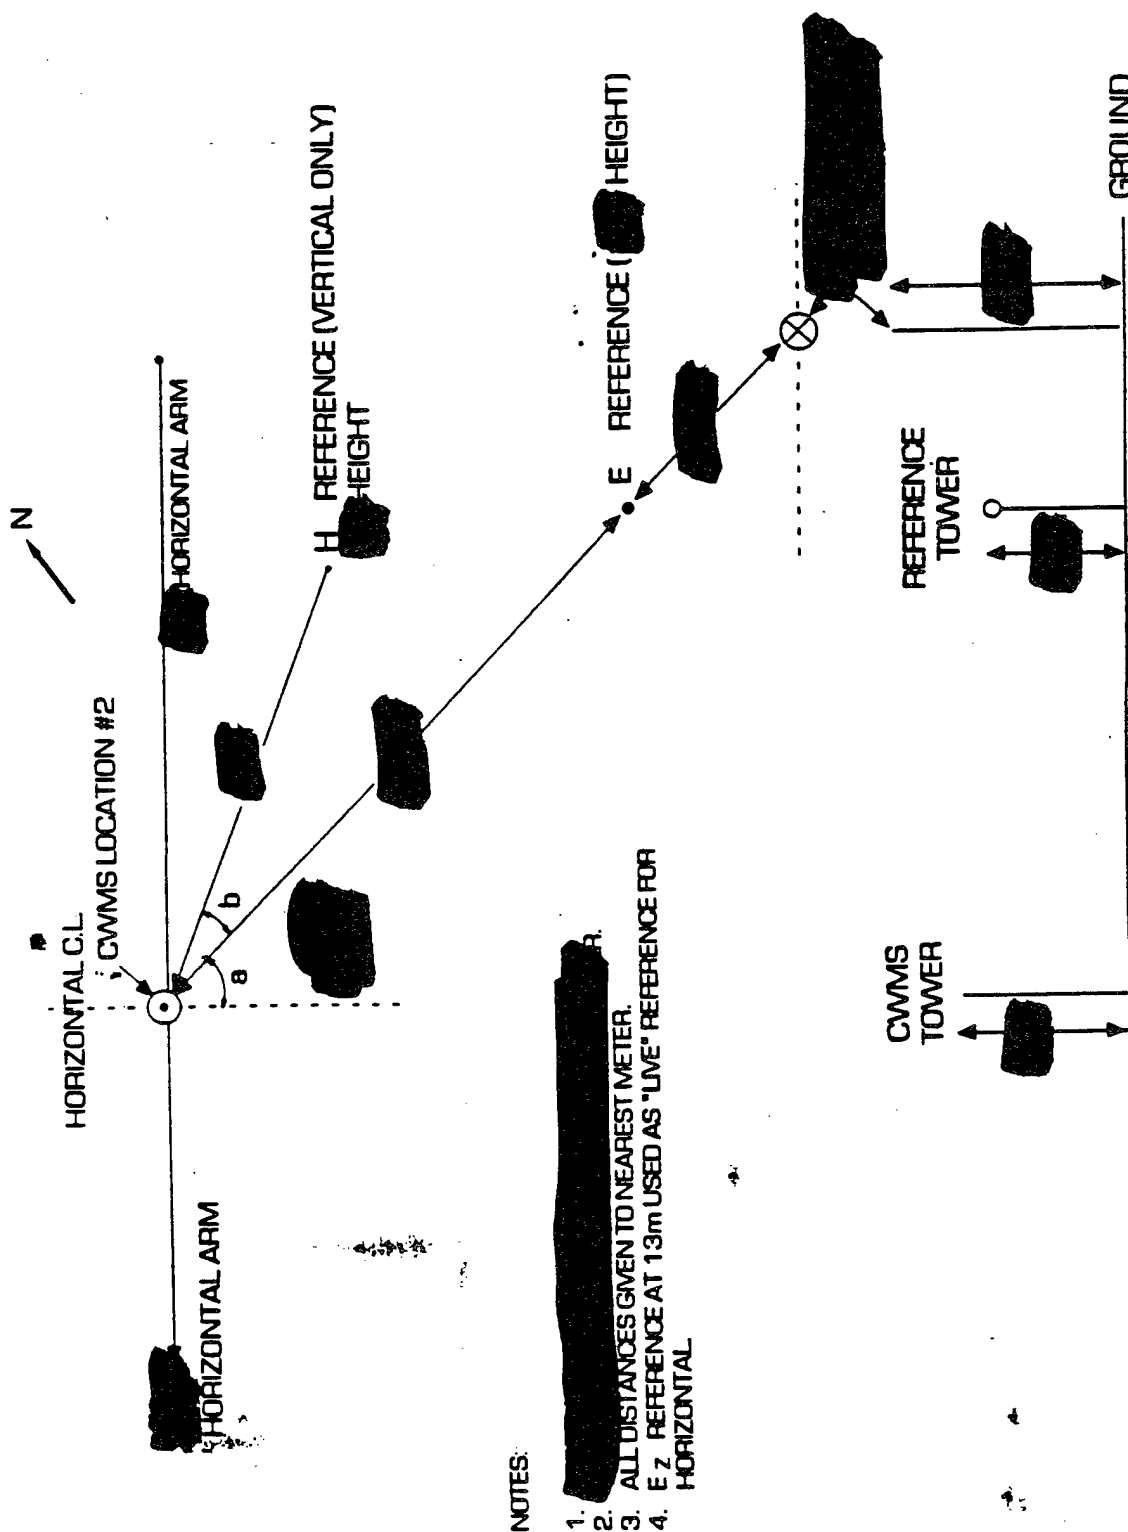
Figure 7. Geometry for [REDACTED] # 9

1. [REDACTED]
2. [REDACTED]
3. ALL DISTANCES GIVEN TO NEAREST METER.
4. E Z REFERENCE AT 13m USED AS "LIVE" REFERENCE FOR HORIZONTAL

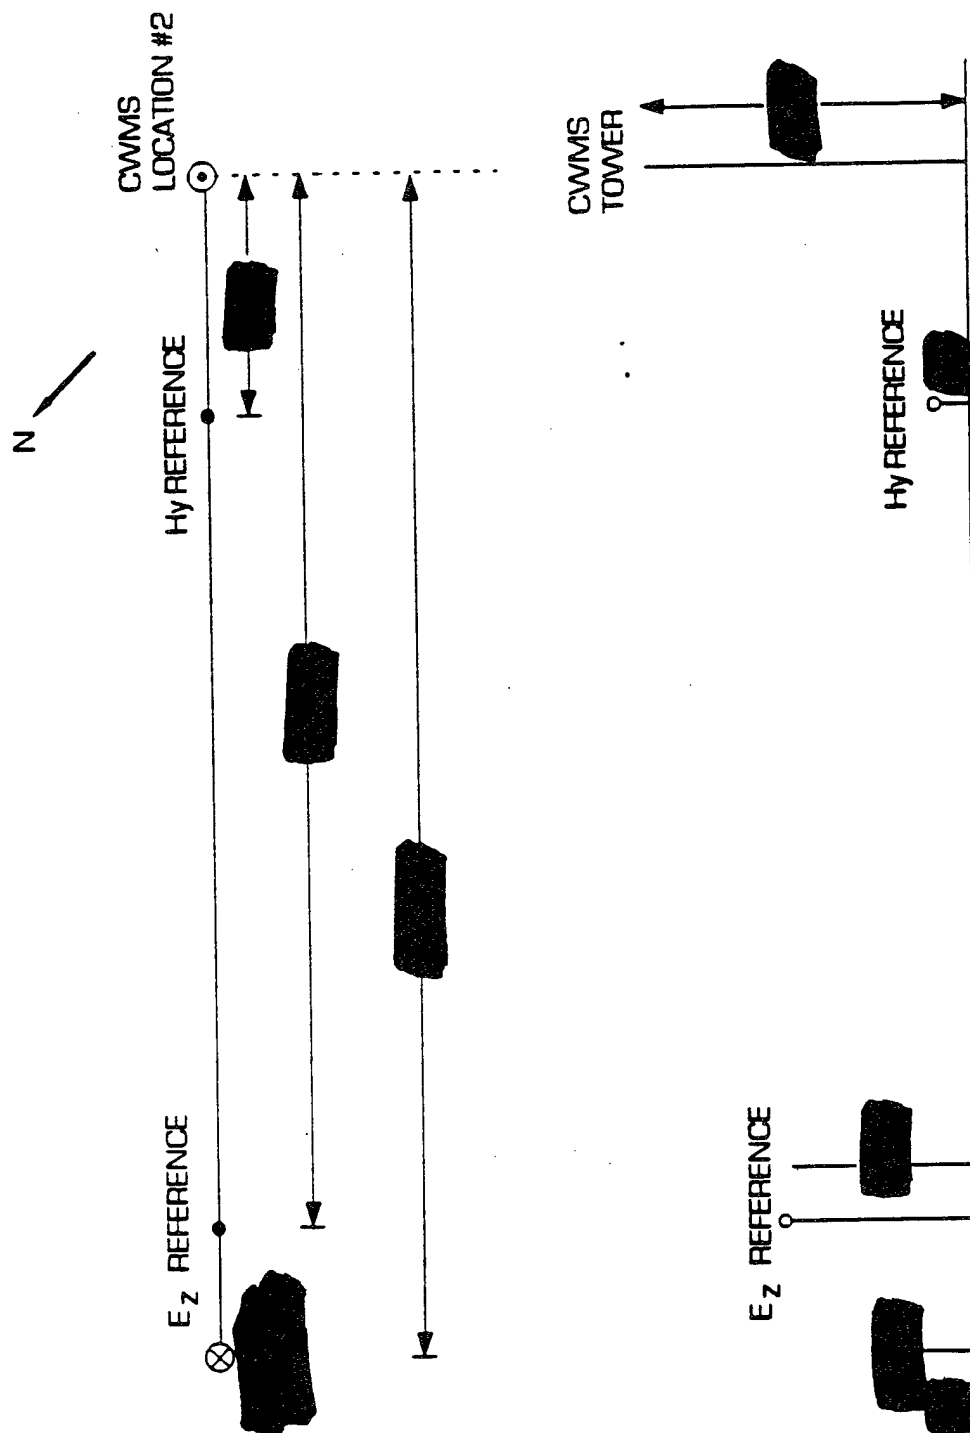
Figure 9. Geometry

1. [REDACTED]
2. [REDACTED]
3. ALL DISTANCES TO NEAREST METER.

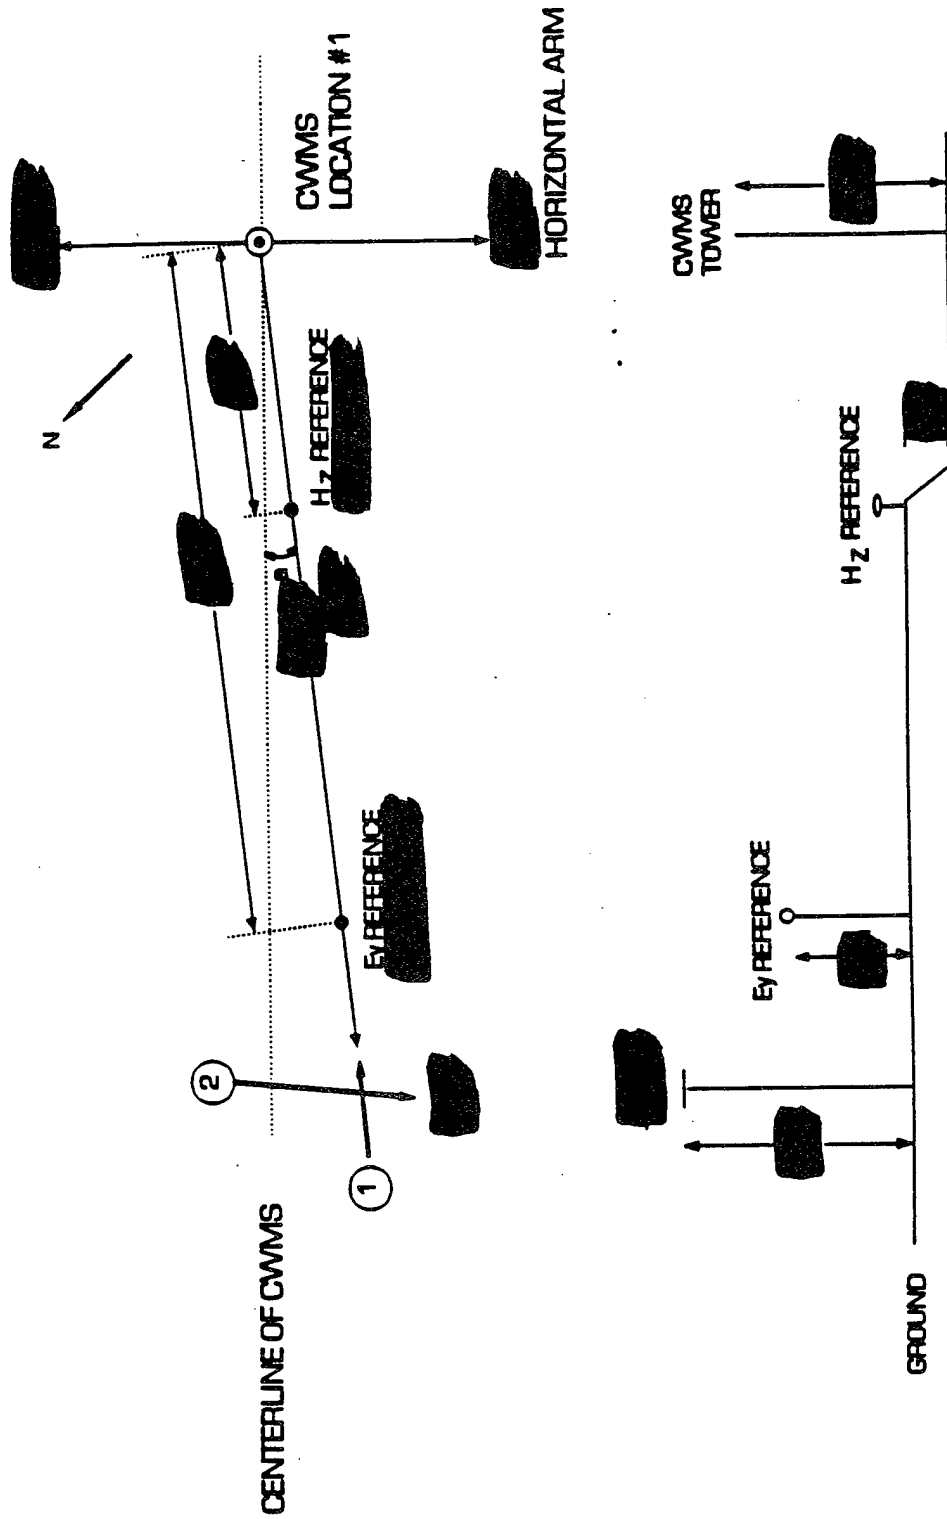
Figure 11. Geometry for CWMS Antenna

1. POINTING DIRECTION
2. CWMS UP ON CENTERLINE.
3. HORIZONTAL POLARIZATION ONLY.
4. ALL DISTANCES TO NEAREST METER.
